Lake Maxinkuckee Shoreline Revegetation Project - 2007

PREPARED FOR:

**LAKE MAXINKUCKEE ENVIRONMENTAL COUNCIL 116 N.
MAIN ST.
CULVER, INDIANA 46511**

V3 COMPANIES 7325 JANES AVE WOODRIDGE, ILLINOIS 60517
630.724.9200

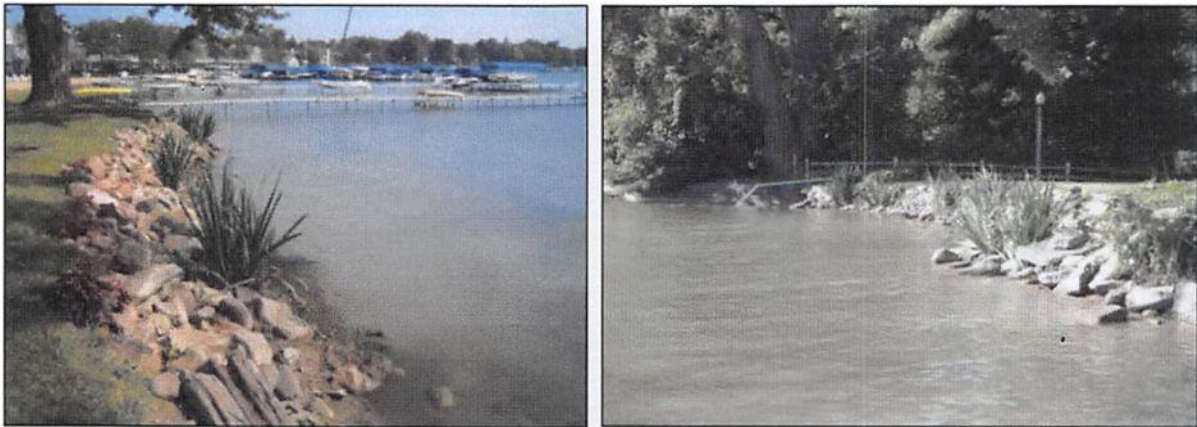
V3 met with Tina Hissong, former LMEC director, to discuss a revegetation design that would provide vegetative structure within the emergent zone of Lake Maxinkuckee as well as please homeowners participating in the revegetation effort. V3 evaluated the project shoreline shown in Exhibit II. The 300 feet of shoreline was characterized by rip rap shoreline, landscaped day lilies and a steep gradient towards the lake. The planting area was shallow throughout the dock area which limited boat traffic. The lake bottom consists primarily of sand, gravel, muck and marl.

Figure 1: Photographs taken during site evaluation prior to revegetation effort.

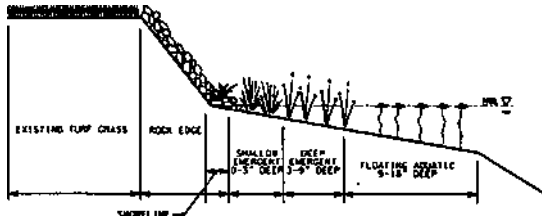
CROSS-SECTION A-A

SILT FENCE DETAIL

V3 installed temporary structures inside emergent zones to serve as a protective enclosure for the shoreline revegetation plantings. Protective enclosures were installed prior to plant installation and were used as a guide for determining planting zones. The enclosures were made of a porous silt fence material which allows for water to move through while dampening the wave energy. This fencing was attached to wooden stakes that were then driven into the lake substrate (Figure 2). The enclosures were v-shaped with the base of the “v” facing away from the shoreline. The direction of the enclosure was important in functioning as a wave break and dissipating the wave energy so most vegetation was not directly disturbed. A permit was required for the placement of these temporary protective structures. The permit for protective enclosures was issued by the IDNR Division of Water. The protective enclosures would remain in place throughout the growing season to assist with survivorship and establishment of the installed plantings. Goose exclusion was also installed as a deterrent to wildlife species that typically forage vegetation (Figure 2, photo on right). Enclosures were removed in the late fall before ice was present and were not replaced during the 2008 growing season.

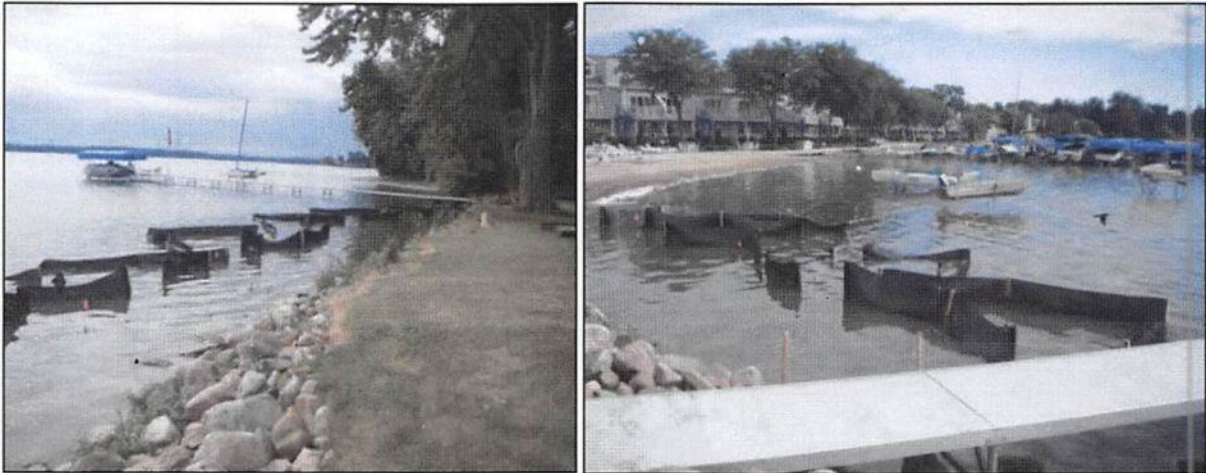
Figure 2: Protective enclosures were used to promote growth of vegetation by serving as wave breaks and wildlife deterrents.

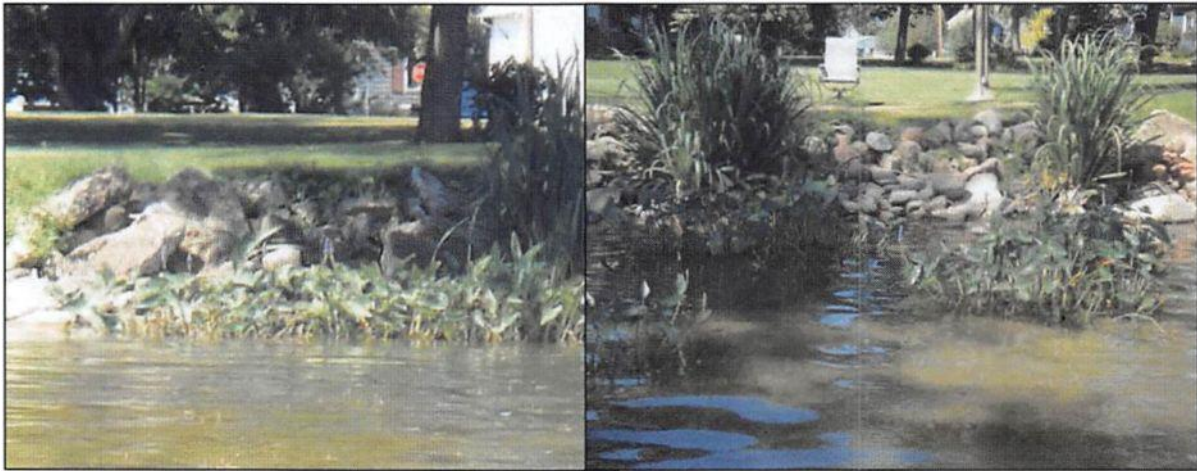
Figure 3: Landward view of established vegetative shoreline and emergent zone communities. (Photo taken August 19, 2008)

V3 performed monthly investigative field visits on August 28, September 15, October 23 and November 20, 2007. One year later, site visits were made on July 8, July 9 and August 19, 2008. During field visits photos were taken to track plant growth within the planting area. Protective enclosures were also evaluated to determine if functionality was maintained. Repairs were made to enclosures as needed during field visits. Lake hydrology was stable throughout field visits. Figures 3 and 4 depict the restoration planting after one year of establishment.

Overall the planting was successful as vegetation is present throughout the planting area. The shallow emergent zone and deep emergent zone experienced the most success after the planting effort. Species within the shallow emergent zone that were the most successful included pickerel weed and arrow arum. White water lily was a floating aquatic species that was present throughout the planting area and did well after planting.

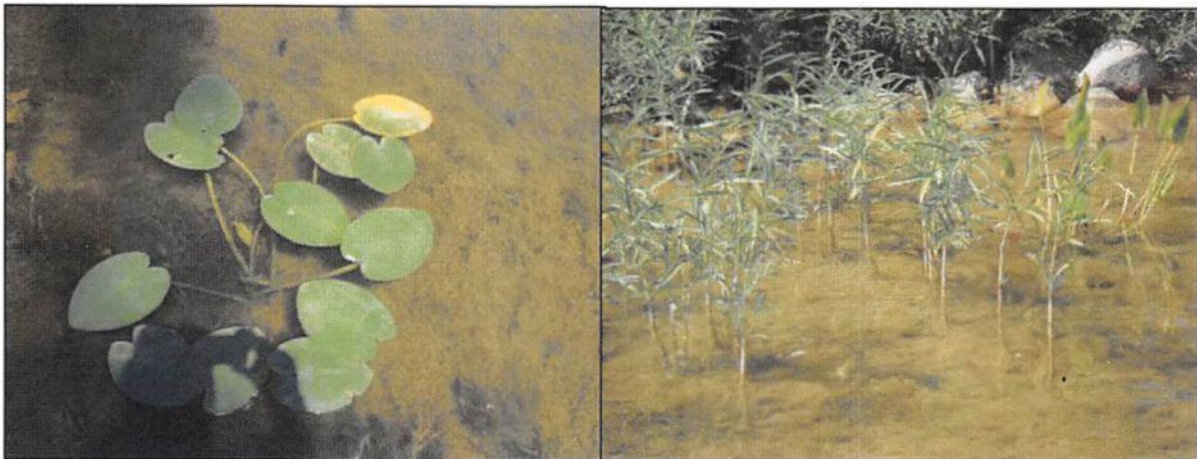
Figure 4: Landward view of established vegetative shoreline and emergent zone communities. (Photo taken August 19, 2008)
